## AVIATION INVESTIGATION REPORT

A04P0206

### ENGINE POWER LOSS

**QUANTUM HELICOPTERS LTD.  
MD HELICOPTER (HUGHES) 369D C-GWPQ  
BOB QUINN AIRSTRIP, BRITISH COUMBIA  
11 JUNE 2004**

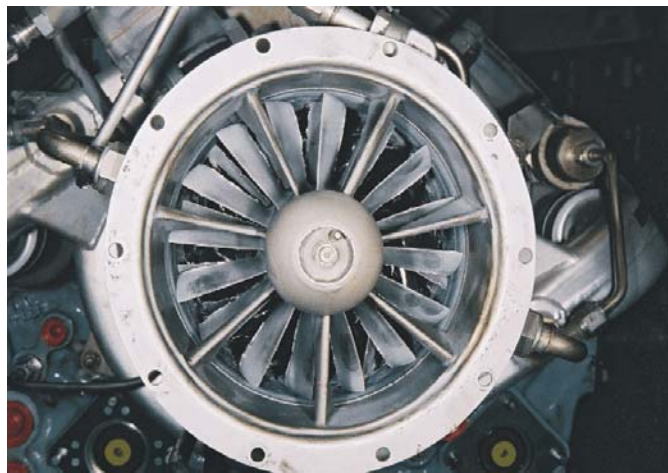
**Photo 2.** Inlet front support guide vanes and first-stage rotor blades leading edges showing minimal foreign object damage.

The leading edges of the compressor front support vanes and 1<sup>st</sup> stage rotor blades were examined in detail for any indication of foreign object damage (FOD). On the leading edge of the front support vane, located at about the one o'clock position, there were two small indentations (Photo 2). The original surface of the vane at each mark was still visible with some oxidation and was not disturbed by any material smearing, indicating that the marks had been present for quite some time. The leading edges of the 1<sup>st</sup> stage rotor blades showed some tip damage on a few blades, and a relatively minor impact mark near the root of one blade that warranted a more detailed examination.

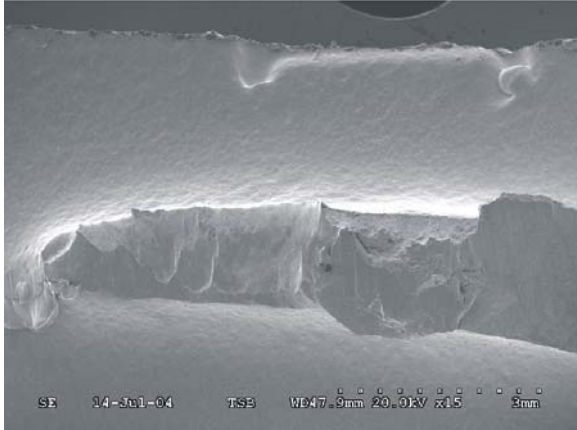
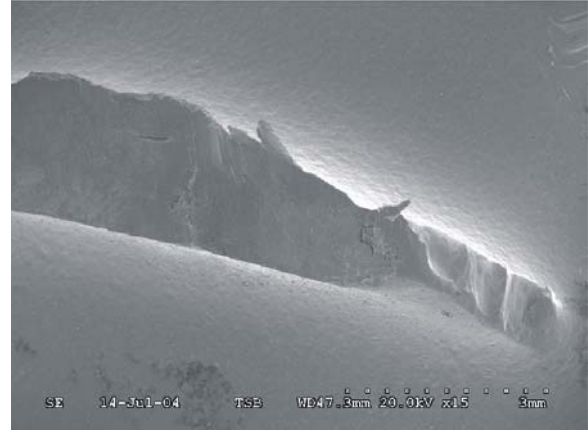
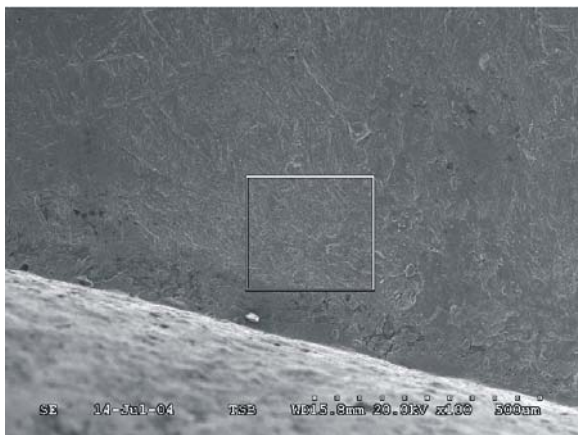
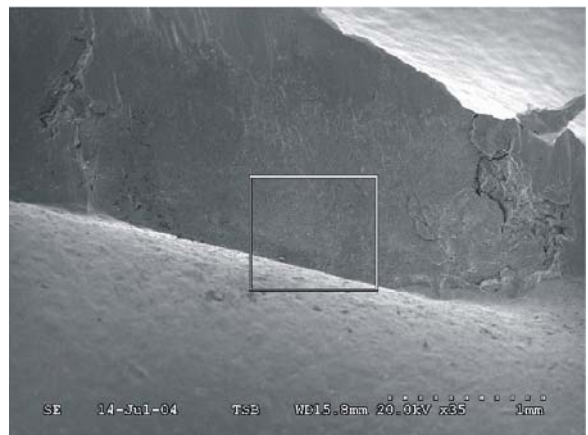
A SEM examination of the 2<sup>nd</sup> stage rotor blade, showing faint striations, confirmed the presence of distinctive fatigue striations beginning near the leading edge of the blade and progressing aft towards approximately mid-span (see Appendix B, photos 3 through 8). The aft section of the blade fracture towards the trailing edge was characteristic of the final overload failure of the blade. All fracture detail in the leading edge region where fatigue initiated had been completely obliterated by post-fracture rub damage.

High cycle fatigue fracture was confirmed for one of the 2<sup>nd</sup> stage rotor blades, and separation of this blade is considered to be the lead event in the compressor failure. This is consistent with the damage pattern observed in the compressor, including the shedding of all of the 2<sup>nd</sup> and 3<sup>rd</sup> stage rotor blades, and the major penetration observed in the case halves in the 2<sup>nd</sup> stage rotor path. Failure analysis of the stator vanes did not reveal any indications of premature failure, and the vane failures were all considered to be secondary in nature, resulting from the initial 2<sup>nd</sup> stage rotor blade failure. This was supported by a review of several other compressor failures for

1. The compressor failure resulted from the separation of a 2<sup>nd</sup> stage rotor blade due to high cycle fatigue, which had initiated at or near the leading edge of the blade. Post-fracture mechanical damage in the origin area prevented determination of the cause of fatigue initiation.

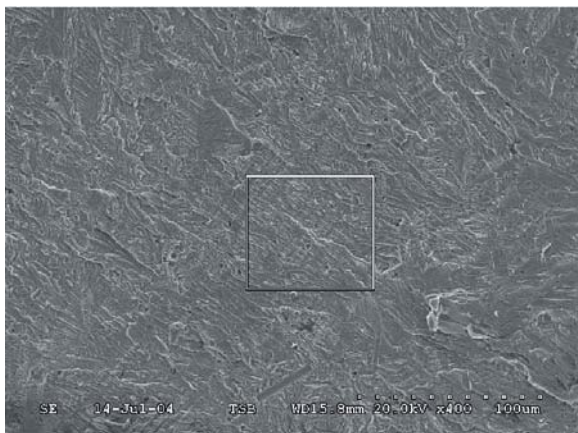
**Photo 7. Fracture surface image**

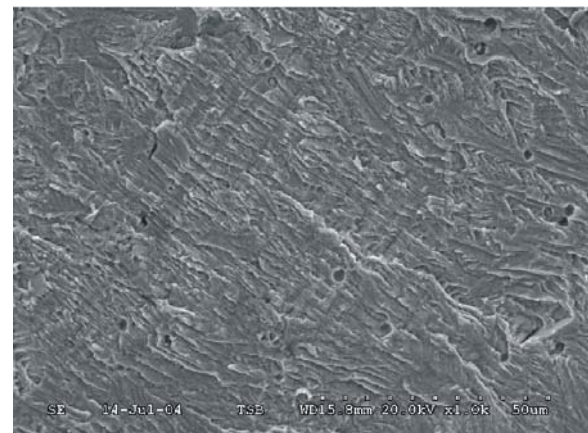
**Photo 8. High cycle fatigue**

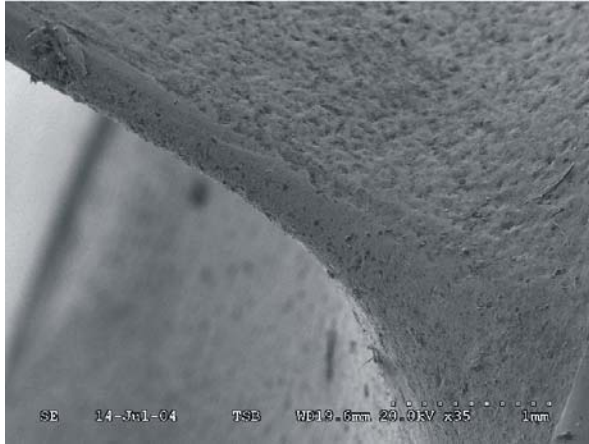
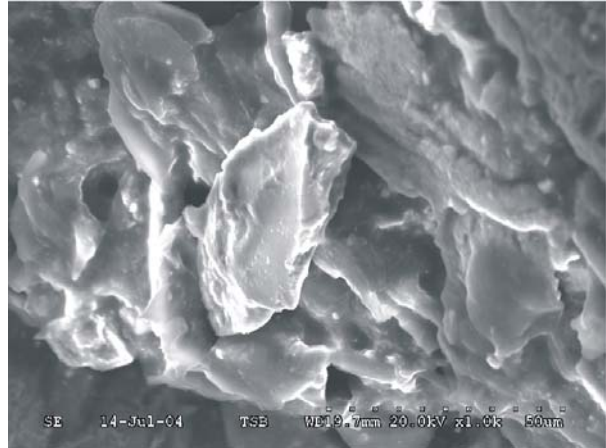
Optical examination of the impact mark showed that the leading-edge material of the blade had been disturbed by contact with a small piece of foreign material or debris, and there appeared to be a small particle of material trapped within the indentation. The indentation was examined at higher magnifications in the scanning electron microscope (SEM). Elemental analysis confirmed the presence of a small aluminum-rich particle that was foreign to the surrounding material of the blade (Appendix C, photos 9 and 10). The material debris that had been collected from the engine cowl area during recovery and the compressor rotor blade pieces were examined, and four pieces of what appeared to be broken rivets were identified. An analysis for material composition showed material spectra containing a predominant nickel peak for sample number 1, predominant titanium and cadmium peaks for sample number 2, and predominant iron and chromium peaks for sample number 3. Sample number 4 was almost wholly aluminum with small amounts of magnesium, which is consistent with a standard aluminum rivet material.

The possibility of FOD as a precursor to the compressor rotor blade failure was considered. But, for a number of reasons, it could not be concluded positively that FOD was a precursor. On this installation, a particle separator was installed; however, there appears to have been impingement by a small foreign particle on one of the 1<sup>st</sup> stage rotor blades, as evidenced by what appeared to be a recent impact mark and a particle of aluminum metal transfer. The engine had continued to run for a short time after ground impact, and it is possible that something was ingested into the compressor at that time, leaving the mark observed on the 1<sup>st</sup> stage blade. On the other hand, the mark on the leading edge of the front support vane was oxidized, indicating that it had been present for some time. Since the debris in which the piece of aluminum rivet was found was collected among general debris found in the engine cowl area after the accident, it cannot be positively linked to the presence of the small particle of aluminum in the impact mark. Given these observations, FOD cannot be ruled out. However, the absence of any fractographic evidence near the fatigue initiation zone makes its influence as a probable fatigue crack initiator in the 2<sup>nd</sup> stage rotor blade inconclusive.

Photos 9 and 10 are SEM images of impact mark at 1<sup>st</sup> stage rotor blade leading edge showing the presence of a small imbedded particle.

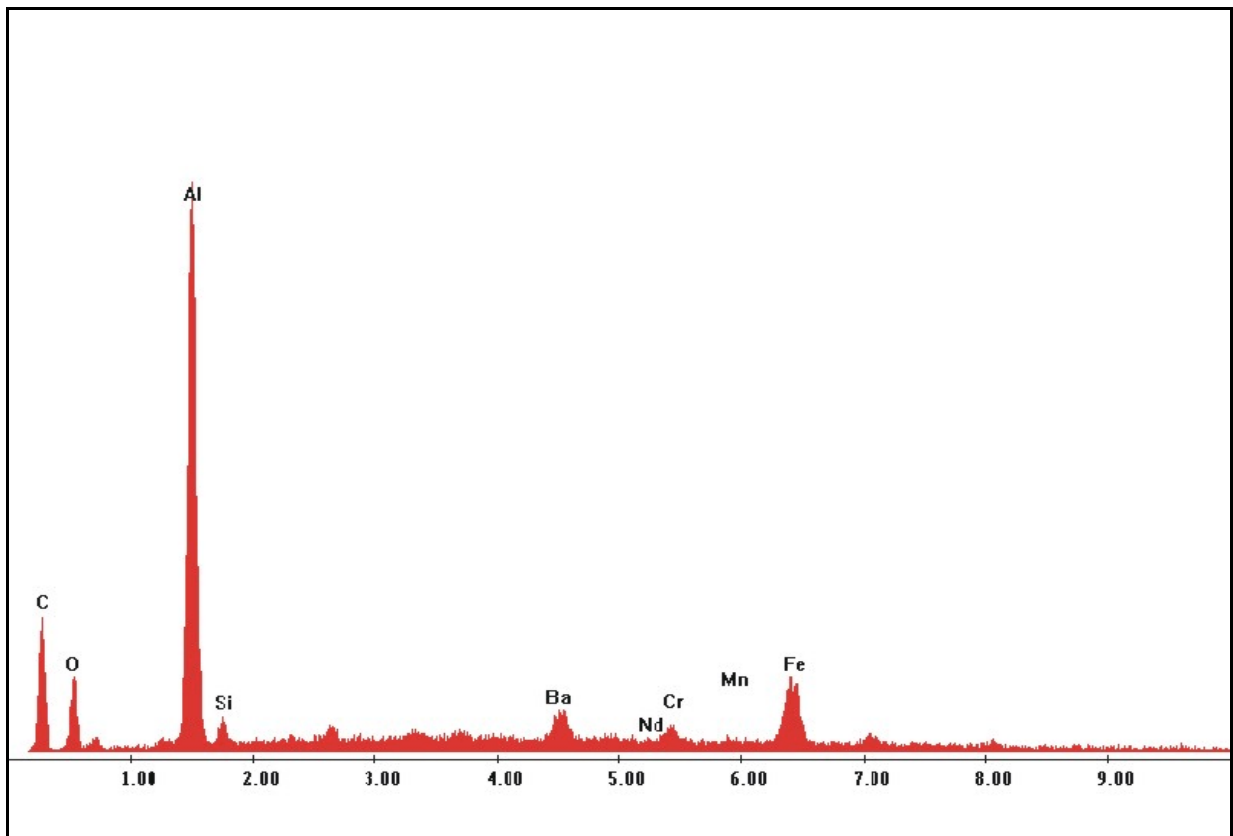
Figure 1. Material analysis spectra of particle revealed a predominantly aluminum composition.
